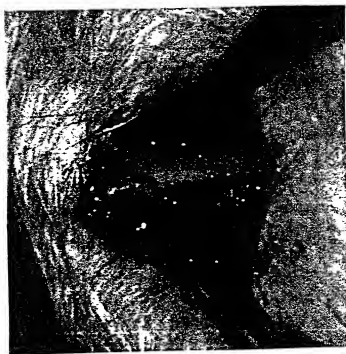
FIG. 1B

EXPOSED FEMUR

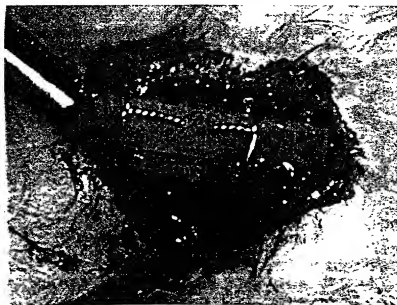
FIG. 1C

PLACEMENT OF FIXATOR PLATE

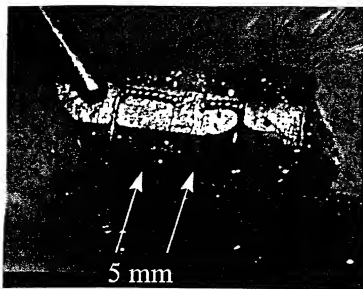
FIG. 2A

CREATION OF GAP DEFECT

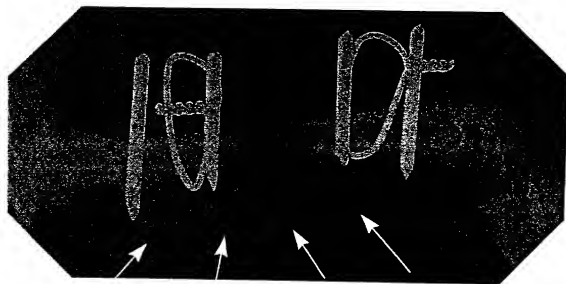
FIG. 3A

MIGRATION OF BONE ALLOGRAFT IN ALGinate (-Ca²⁺)

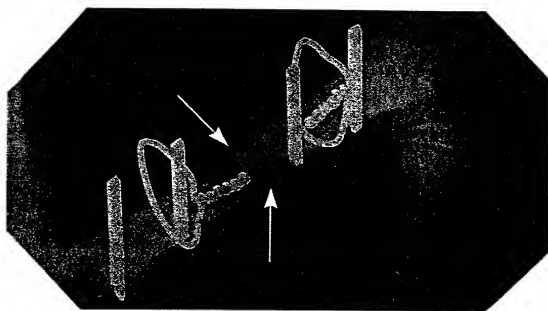
FIG. 3B

BONE ALLOGRAFT IS RETAINED WITH ADDITION OF Ca^{2+}

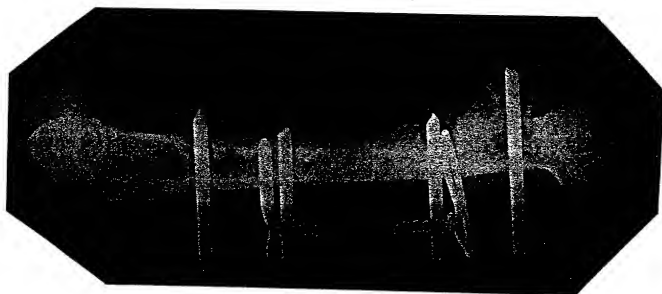
FIG. 5

12 WK DBM IN HA+VEGF

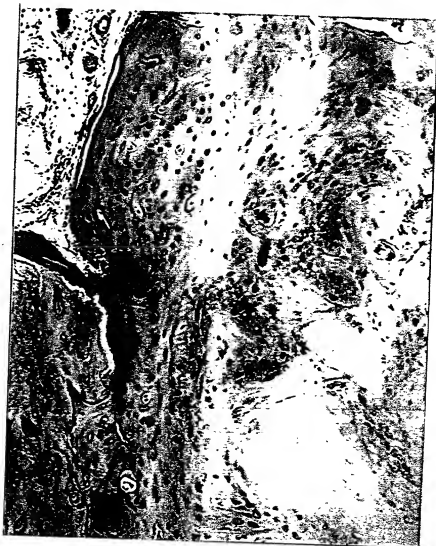
FIG. 6

12 WK DBM IN HA+VEGF
